# PMS: Is It a System

By ETC(SW) Henry DuPlantier,  
Naval Safety Center

# n Or a Syndrome?

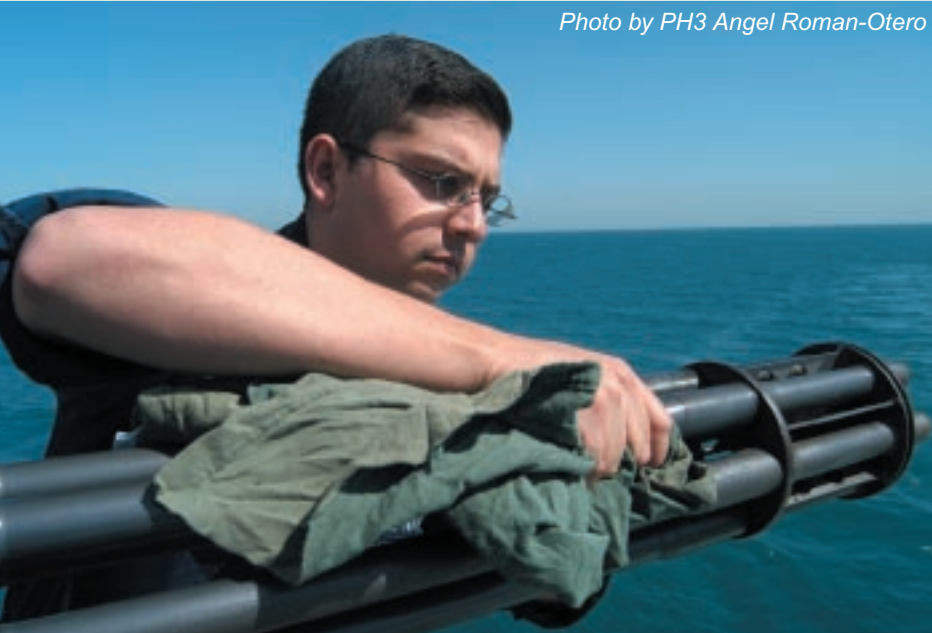
FC3 Adrian Herevia conducts preventative maintenance and corrosion inspection on a Close-In Weapons System (CIWS) gun barrel aboard USS *Kearsarge* (LHD 3) during the ship's participation in support of Operation Iraqi Freedom.

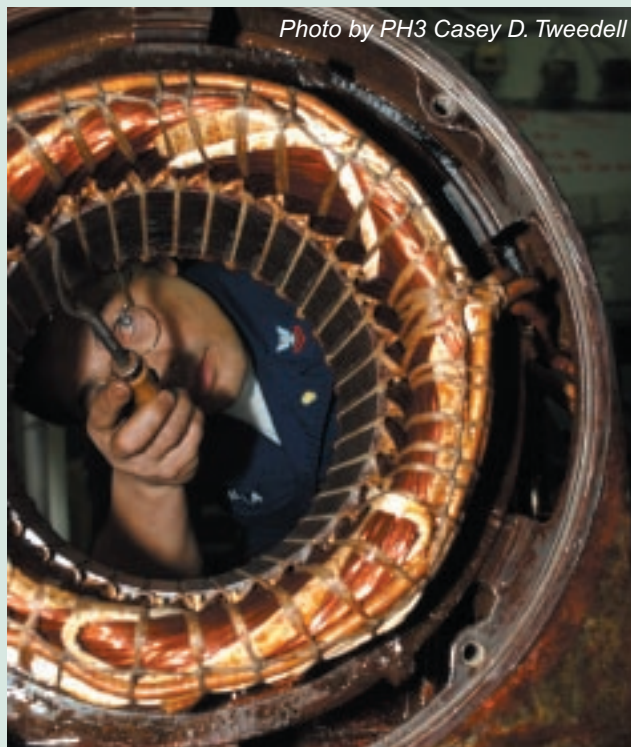
A USS *Constellation* (CV 64) electrician repairs a generator in the ship's motor-rewind shop. One problem discovered during Naval Safety Center surveys is that of electrical work-bench PMS often being overdue or ignored.

**Electrical.** Electrically-safe workbenches are not in compliance with requirements for insulation, equipment ground leads, and power disconnects. Such benches require an annual PMS check, with a record maintained in the tool-issue room, along with records of electrical-safety checks on power tools. Workcenters working with energized equipment during bench-testing should review MIP 6652/006 and familiarize themselves with bench-testing procedures.
